Technical Service Bulletin Number	Revision Level	Date	Group Number
TSB130159

Fault Code 3167 or 1691 Caused by a Missing Poppet in the EcoFit™ Aftertreatment Fuel Injector

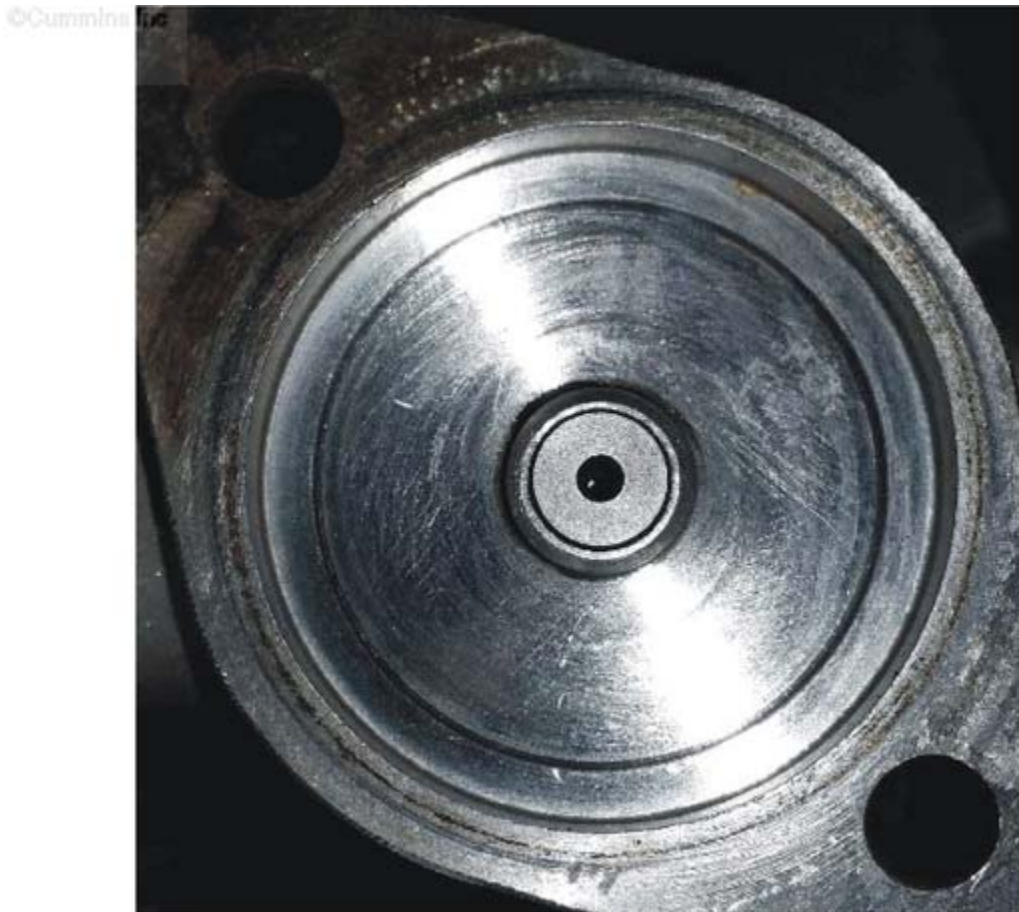
This issue is isolated to the new EcoFit™ aftertreatment fuel injector design. The new EcoFit™ aftertreatment fuel injector is susceptible to the inner poppet falling out due to a worn retaining spring retainer. This situation can increase the probability of fouling that can cause a high restriction of the injection of fuel into the aftertreatment system.

Malfunctioned EcoFit™ aftertreatment fuel injectors will have a hole in the center of the injection point. A normal EcoFit™ aftertreatment fuel injector will have a visible plunger (poppet) at the center of the injection point.

Missing Poppet - EcoFit™ Aftertreatment Fuel Injector

If the EcoFit™ aftertreatment fuel injector is missing the lower poppet, replace the aftertreatment fuel injector.

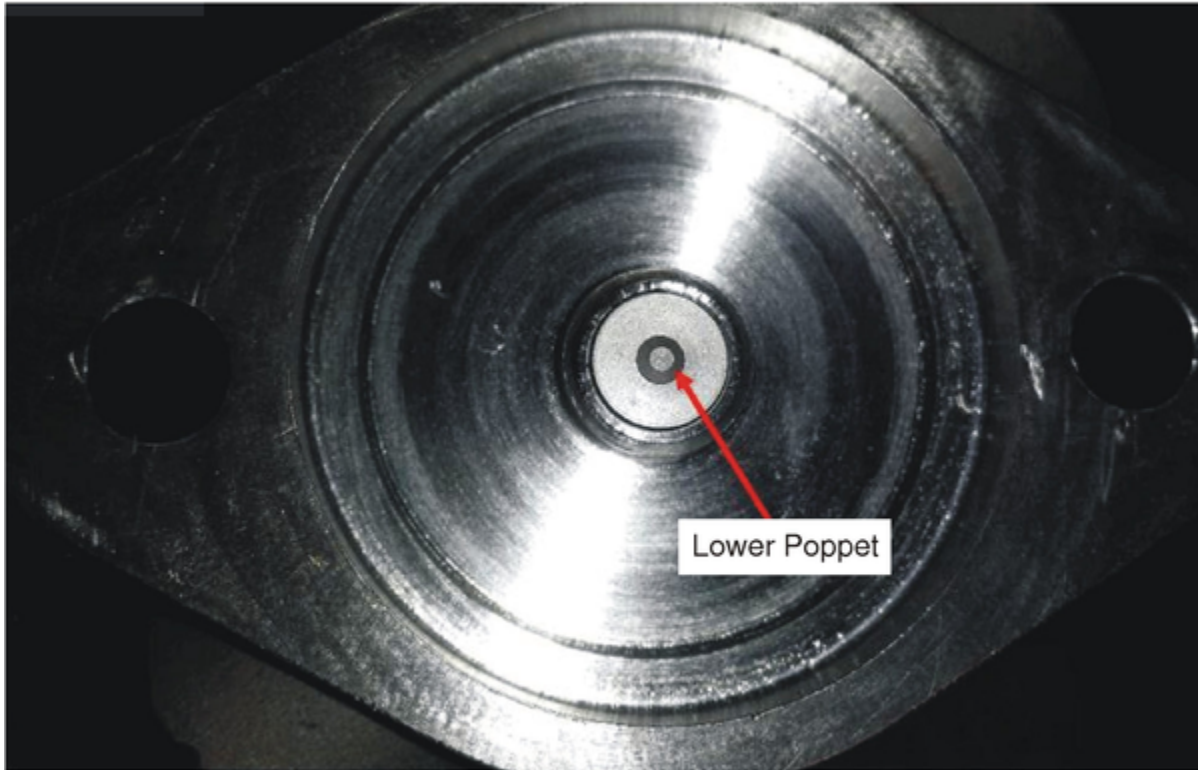
11a00097

Poppet - EcoFit™ Aftertreatment Fuel Injector
